SUPERCAR LITES

Technical Bulletin

Number	SCL_TB_004	Date	04.01.2018
Revision	001	Issuer	Mountune
Mountune 002 – Page 1 / 3

IMPORTANT RX2 / GRC LITES TEAM BULLETIN

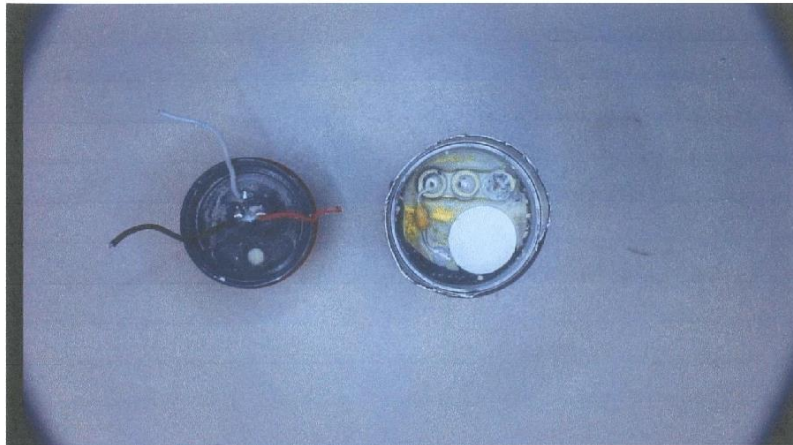
From an investigation into the failure of engine pressure sensors, which are mounted on the bulkhead sensor block, moisture has been found internally on the PCB, cell membrane, housing and plug.

Therefore the sensors must be being subjected to high pressure water jets for a period of time allowing the ingress of water/moisture, most likely during Jet washing the cars.

Picture1: moisture in the housing and plug

To reduce pressure sensor failures, these **MUST NOT BE** jet washed.

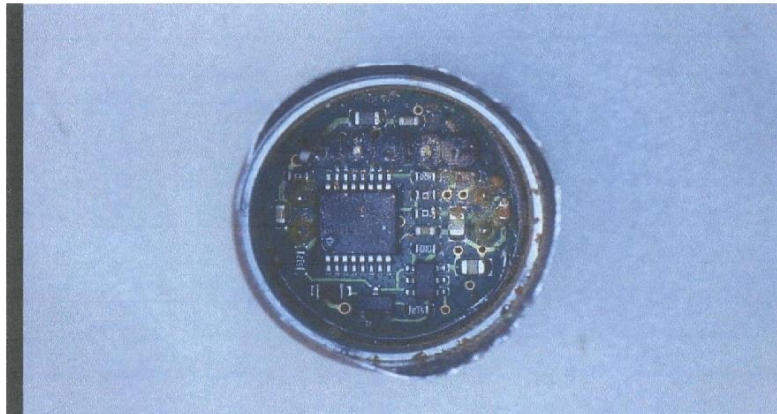
Picture2: moisture on the PCB

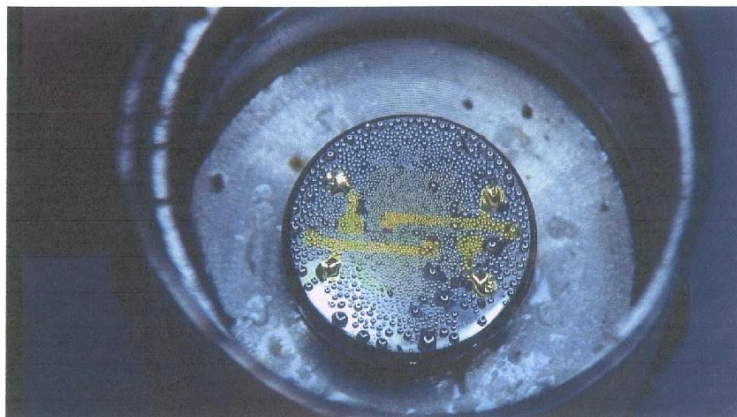
Picture3: moisture on the cell/membrane
