SUPERCAR LITES

Technical Bulletin

Number	SCL_TB_006	Date	04.01.2018
Revision	001	Issuer	SuperCar Lites
Coil Pack

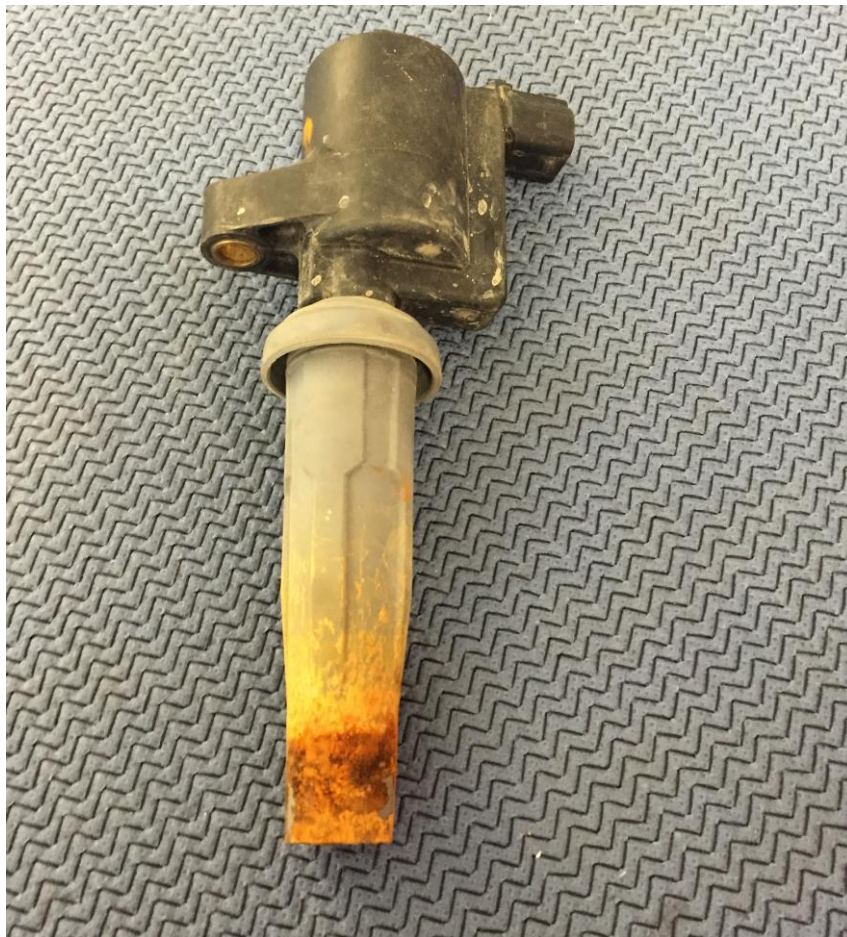
We have seen a number of engines where the coil packs particularly on cylinders 2 & 3 are coated in rust when removing. This is caused by water which sits in the spark plug hole and can cause misfire. We recommend that when cleaning engines you do not directly spray the coil packs. In order to ensure that there is no issue we also recommend after cleaning or a wet race that you remove the coil packs and dry out the holes.
